RICHELIEU RIVER BASIN
WOODBURY, VT

EAST LONG POND DAM
VT 00185

PHASE I INSPECTION REPORT
NATIONAL DAM INSPECTION PROGRAM

APRIL 1980

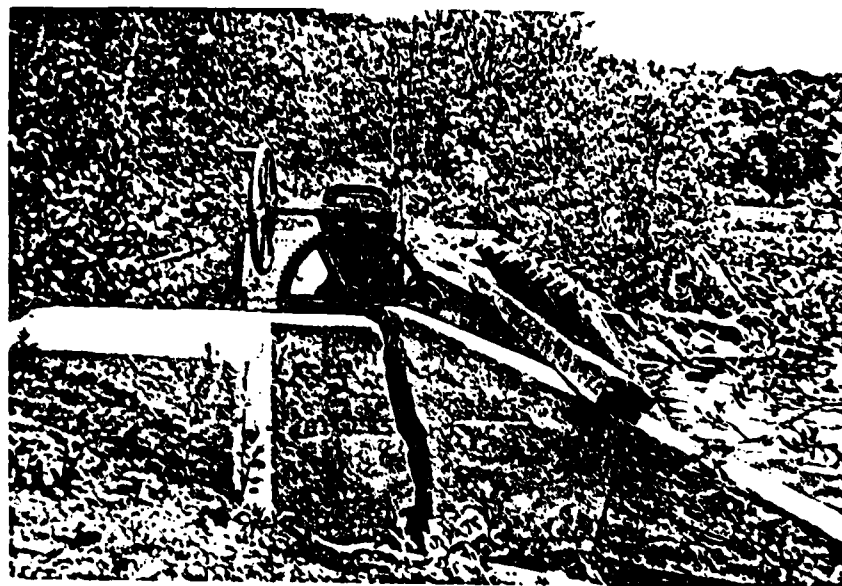
Settlement has also occurred in the spillway and gate section, resulting in a crack in the west wing wall, indicated in the photograph below. The separation at the top measures about 5 inches. The condition, ^{at this time.} however, does not adversely affect the stability of the section. It is noted that the wing wall construction consists of a concrete extension, built on an existing stone masonry wall.

Spillway and Gate Section of East Long Pond Dam, Equipped with Timber Trash Rack.

(Note settlement crack in wing wall. Also note overgrowth on earth embankment.)

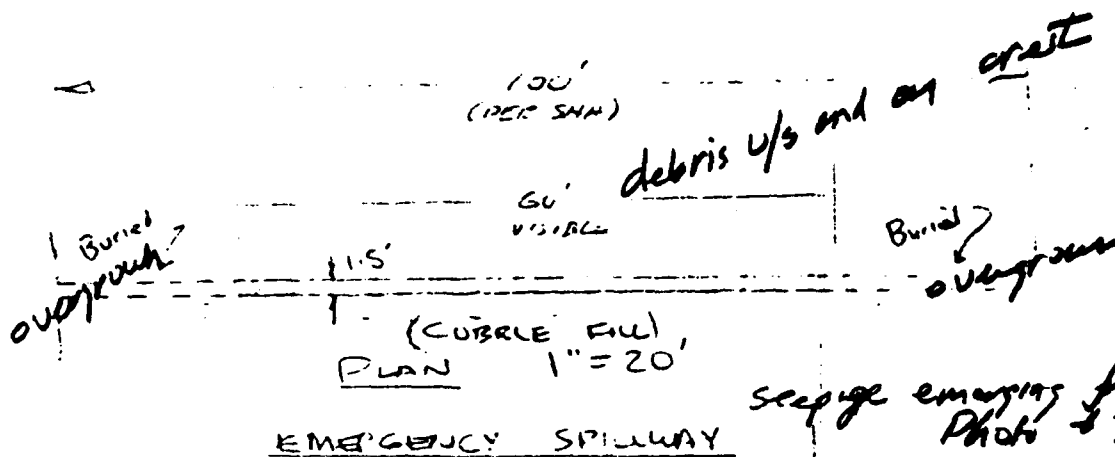
seepage emerging from d/s
Photo 79-25-2
